# Test Report

Report No.: AGC07686200501SR01

**PRODUCT DESIGNATION** : M8 female straight molding cable,  
M8 Male straight molding cable,  
M8 female right angle molding cable,  
M8 Male right angle molding cable

**STANDARD(S)** : IEC60529:1989+A1:1999+A2:2013 IP67

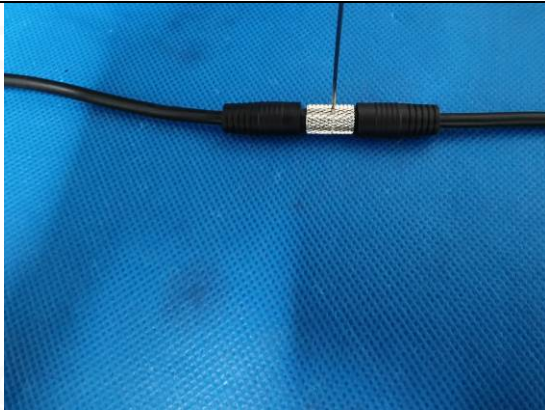
Use a rigid steel rod (1 mm diameter) push against any openings of the enclosure, the test force is 1N.

200527009-(001-002) Probe Test

Sample No.	Test result	Judgment
200527009-(001-004)	The test probe could not penetrate the inside of the sample; After the test, no dust inside the sample by visual inspection.	Pass

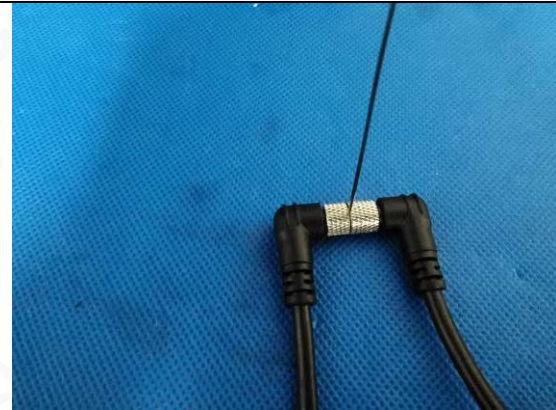
200527009-(003-004) Probe Test

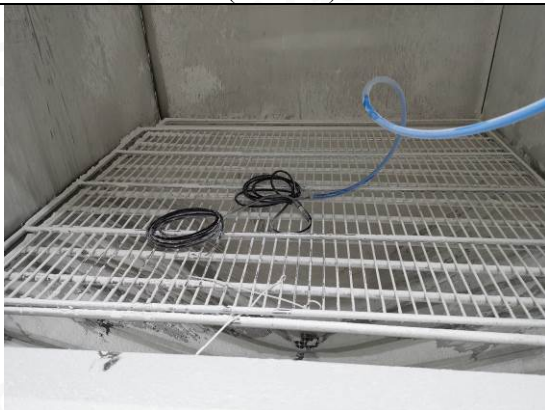
1) The sample is pumped at negative pressure, the volume of air is <40times the volume of the shell per hour, the pressure inside the sample shell and the pressure outside the shell are not more than 2KPa

2) The amount of talcum powder: 2kg/m<sup>3</sup>

3) Test duration: 8H

200527009-(001-002) Dust Test

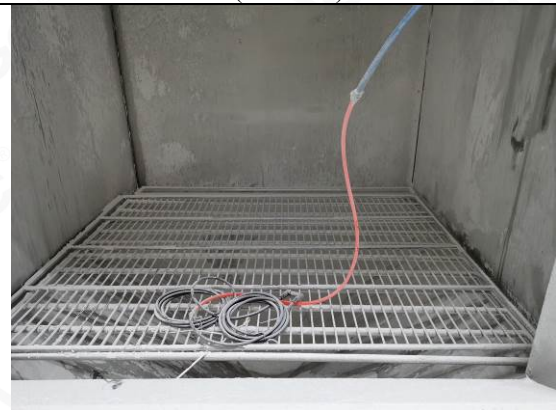
200527009-(003-004) Dust Test

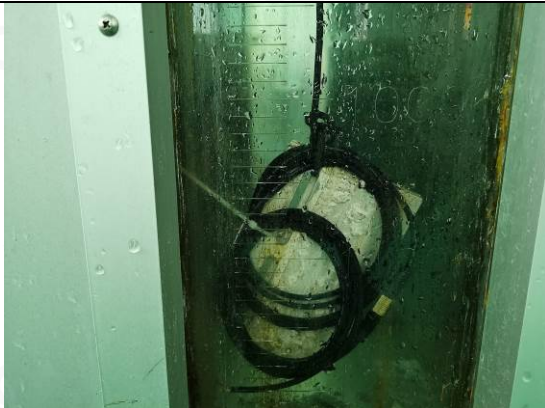
200527009-(001-002)

- Water-Level On Sample: at least 0.15 m above the top of the sample device, and at least 1 m above the bottom of the sample device.
- Test Duration: 30 min.

Sample No.	Test result	Judgment
200527009-(001-004)	After the test, no water inside the sample by visual inspection.	Pass
